ASSESSMENT OF THE EFFECTIVENESS OF DIFFERENT SAFETY MEASURES AT TUNNEL LAY- BYS AND – PORTALS TO PROTECT OCCUPANTS IN PASSENGER CARS

Ernst Tomasch

Graz, 1st December 2020

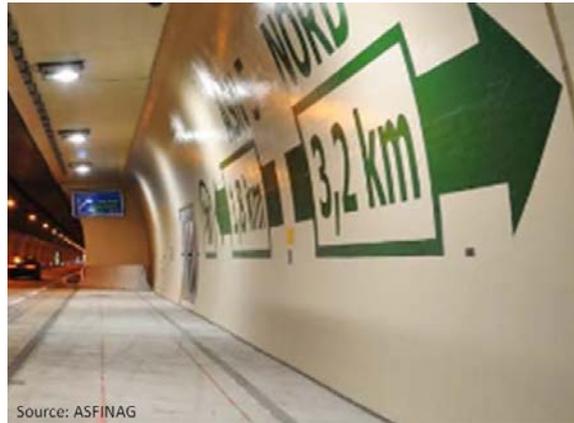
Angular positioned concrete barrier

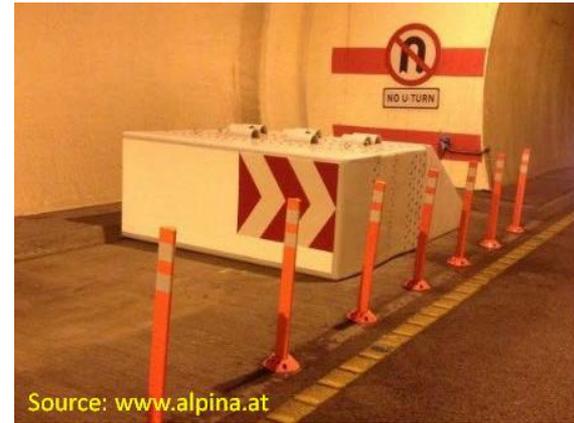
Crash cushion

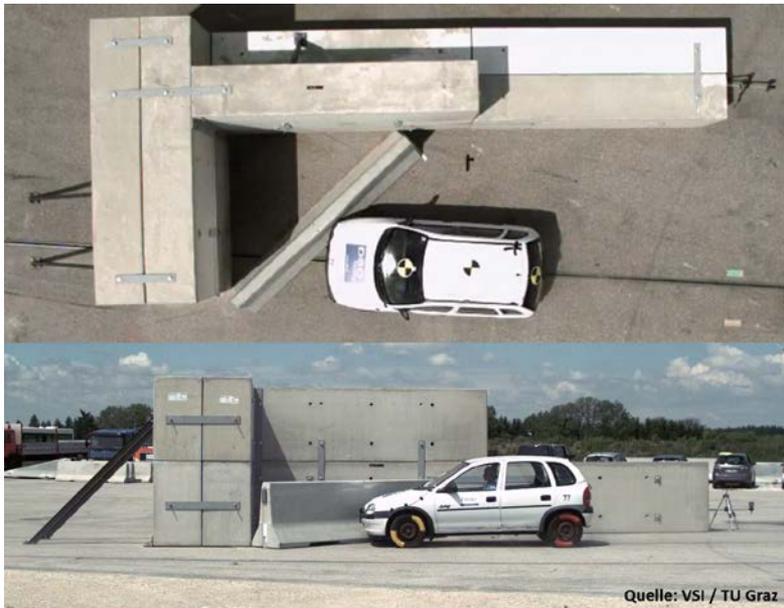
- Angular positioned 4 m and 8 m concrete barrier

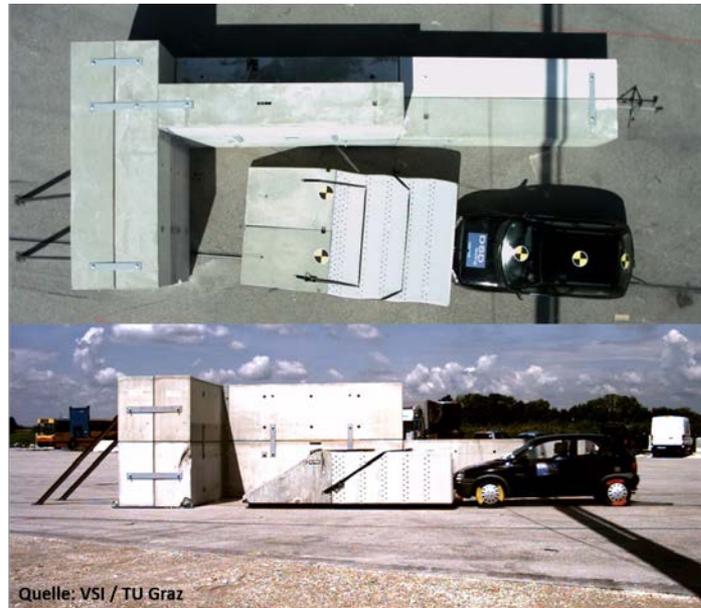
- Crash cushion
 - Alpina F1-50 not designed for this speed limit,
 - Alpina <prototype>
