ASSESSMENT OF THE EFFECTIVENESS OF DIFFERENT SAFETY MEASURES AT TUNNEL LAY-BYS AND PORTALS TO PROTECT OCCUPANTS IN PASSENGER CARS

¹Ernst Tomasch, Simon Heindl, Gregor Gstrein, Hermann Steffan
¹Graz University of Technology

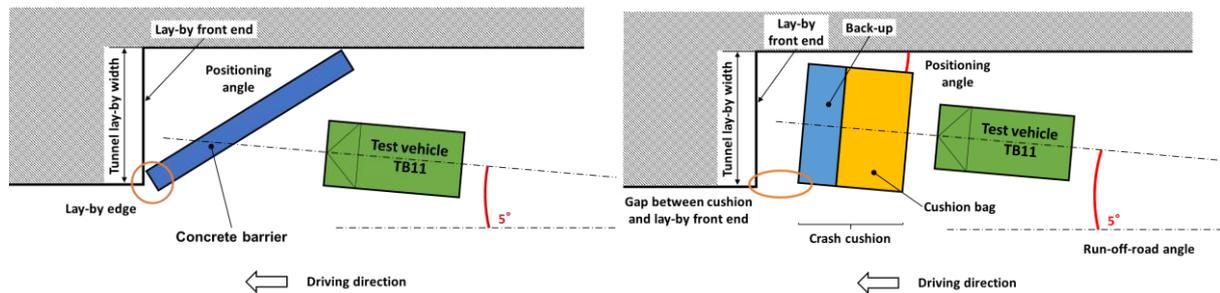
Figure 1: Sketch of the test set-up for an angular positioned concrete barrier (left) and the crash cushion (right)

The position of the concrete barrier is based on the length of the barrier and the width of the tunnel lay-by (Figure 1). The width of the tunnel lay-by is 2.7 m according to the minimum requirements in the RVS 09.01.24. For the 4 m barrier the positioning angle is 42° and for the 8 m barrier 18° . The collision angle calculated from the positioning angle and the run-off-road angle is 47° for the 4 m barrier and 23° for the 8 m barrier. The positioning angle of the crash cushion is 5° that the vehicle impacts the crash cushion with an angle of 0° . The energy absorbing structure (“cushion bag”) of the crash cushion is mounted to a triangular shaped concrete wall which is called “back-up”. The crash cushion is positioned approximately 1.0 m ahead of the front end of the tunnel lay-by.

The impact point is defined in the mid of the concrete barrier that the right front corner of the vehicle impacts the mid of the concrete barrier. For the crash cushion the impact point is at the centre line that the vehicle impacts the crash cushion with the full frontal overlap.

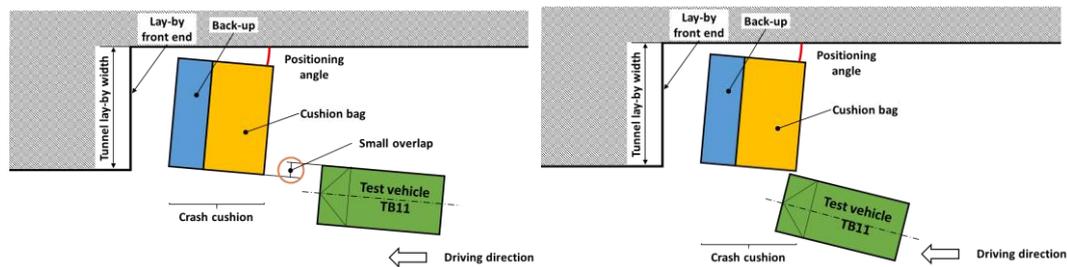
Figure 2: Crash configurations for crash cushion. On the left a small overlap of the vehicle and on the right an impact into the transition of the cushion bag to the concrete back-up.

For real accident impact configurations the testing of crash cushions with a small vehicle overlap would be of interest, i.e. the vehicle impacts the crash cushion with a small overlap (Figure 2 left).

Although the analysed crash cushions are non redirective, assessing the performance of impacts on the side of the crash cushion would be of interest (Figure 2 right). The transition from the cushion bag to the concrete back-up in particular, is assumed to represent a higher risk.

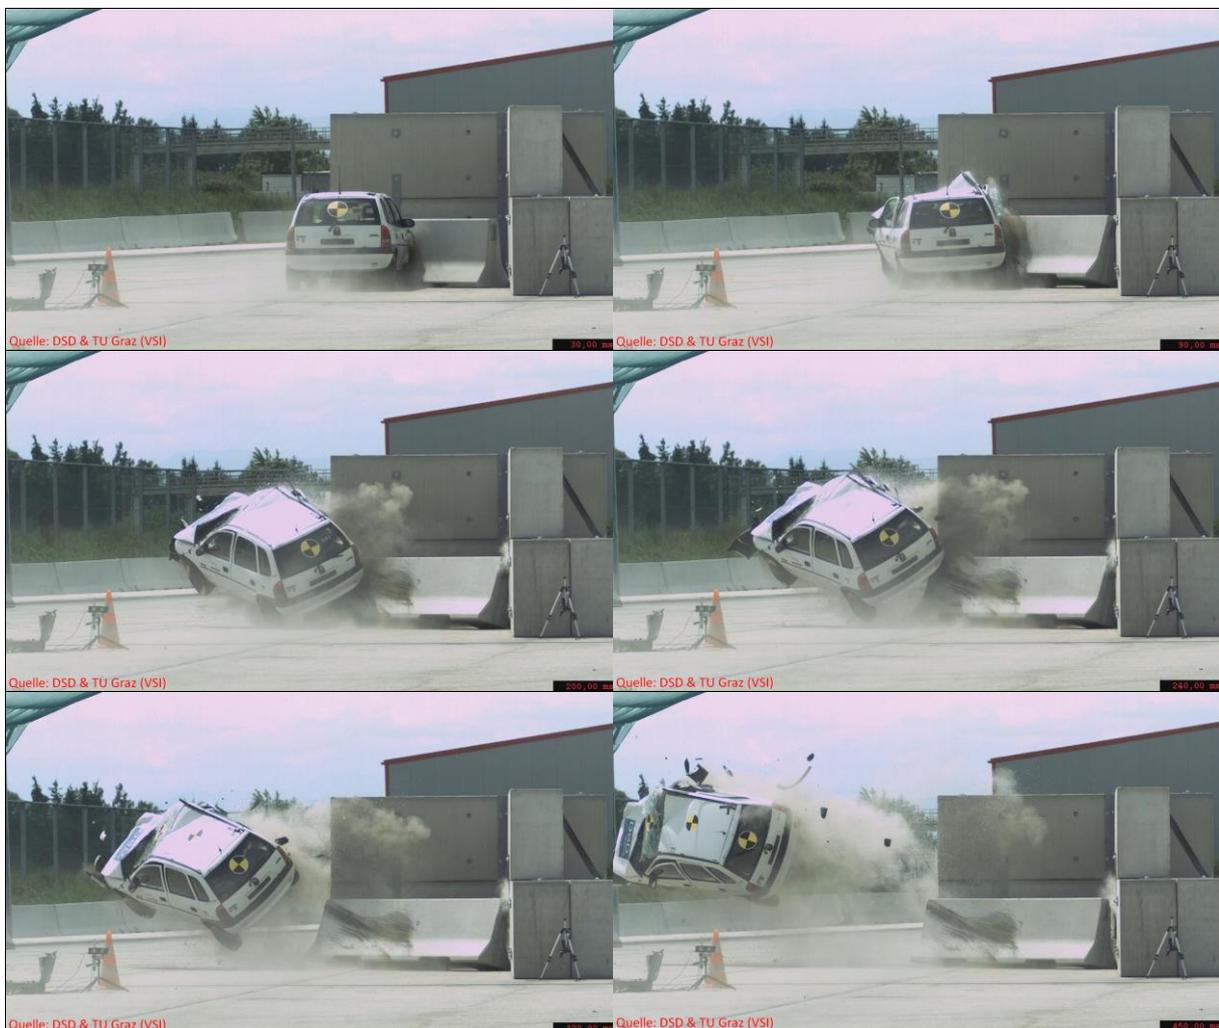
Appendix A - 4 m concrete barrier

The top of the concrete barrier had a contact with the front end wall of the tunnel lay-by due to the impact. This is disadvantageous for the vehicle kinematics in terms of supporting the vehicle lift up. After the impact the vehicle is redirected according to the positioning angle of the barrier. The vehicle was lifted up and rotated approximately 90° counter clockwise to its own longitudinal axis. At the side of the test area concrete barriers was positioned to prevent the vehicle to leave of the test site. The vehicle impacted these concrete barriers with its roof. The maximum distance of the vehicle to the road surface during the flight phase is roughly 1.4 m (see Appendix). The vehicle impacted the safety fence of the crash facility in the flight phase. The flight distance after the impact to the safety fence is approximately 14 m. The right A-pillar and the header rail are damaged and intrusions into the passenger compartment are observed. The acceleration index ASI is calculated to 2.9 and THIV is calculated to 53 km/h. The change of velocity (Δv) is 43 km/h. The post-crash speed is approximately 57 km/h.

The protection of the tunnel lay-by with a concrete barrier of 4 m in length can not be recommended. After the impact the vehicle is raised up above the road surface and a secondary impact with the front end wall of the lay-by could occur as a result. When this does not occur, however, the body of the vehicle is redirected into the road lane with an angle corresponding to the positioning angle of the concrete barrier. A secondary collision with the tunnel wall on the left road lane will occur. The change of velocity at the primary impact is approximately 43 km/h and the secondary impact at the left tunnel wall would be at approximately 60 km/h. After the impact the vehicle rolled counter clockwise with a relatively high flight height and at the secondary impact the occupants were out of position. Airbags were already triggered at the primary impact and had no protective function at the secondary impact. The safety belt provides optimal occupant protection if both airbag and safety belt are still operational in a coordinated manner and when the vehicle is in an upright position. According to the requirements of the EN 1317-2 a moderate rolling only is acceptable and the post-crash motion can then be controlled. Neither, a moderate rolling, nor a controlled post-crash motion were observed in the test.

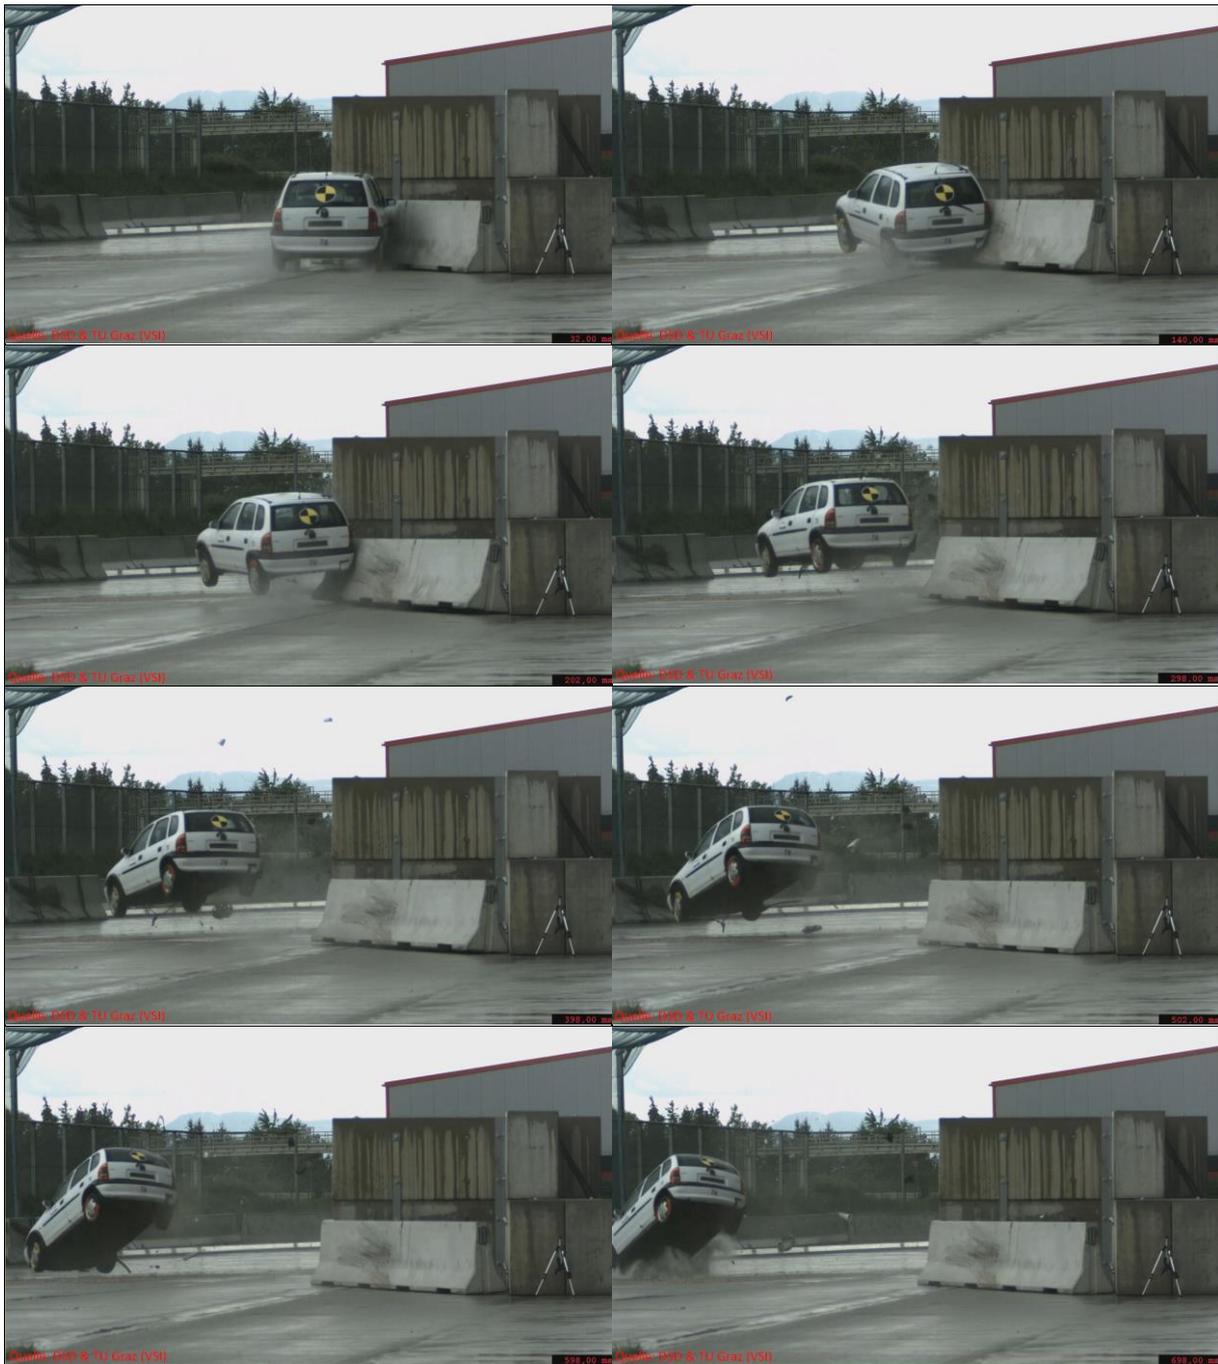
Appendix B - 8 m concrete barrier

After the impact the vehicle was lifted from the road surface and had a flight height of approximately 0.5 m. The vehicle had a high pitching angle and the rear wheels had a maximum height of approximately 1.0 m. The flight distance of the vehicle was approximately 10 m. In the rollout phase the vehicle impacted the concrete barriers positioned to prevent the vehicle to leave of the test site in an upright position. No damage to the passenger compartment was observed. The ASI is calculated to 1.6 and THIV is calculated to 30 km/h. The change of velocity is 22 km/h. The speed after the impact is approximately 78 km/h.

Although the vehicle does not show a rotational motion around the longitudinal axis at the 8 m concrete barrier, it is nevertheless lifted from the surface due to the impact. The vehicle is redirected into the road after the impact with a run-out angle of 23° which corresponds to the positioning angle of the barrier in the lay-by. The change of velocity to 22 km/h is much lower compared with the 4 m concrete barrier. Thus the vehicle would collide with the left tunnel wall

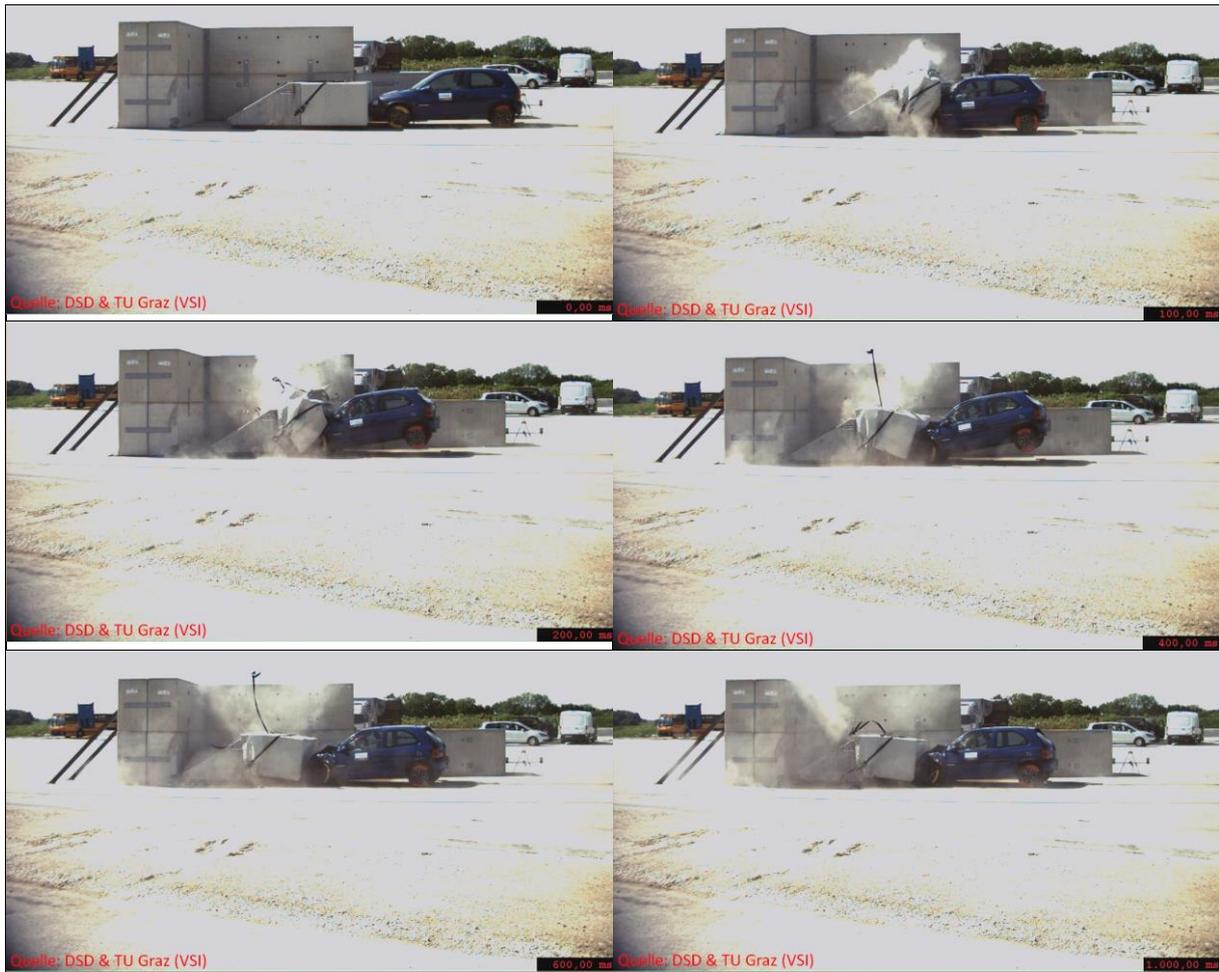
Appendix C – Crash cushion Alpha F1-50

The vehicle is fully decelerated. At the time when the vehicle stopped the crash cushion was pushed forward into the front end of the tunnel lay-by. Simultaneously the vehicle started to accelerate against the pre-crash motion direction due to the elastic restitution of the vehicle and the crash cushion. The final rest position was approximately 0.4 m in front of the damaged crash cushion. During the impact the wheels were lifted approximately 0.5 m above the road surface.

The crash cushion was completely destroyed. The vehicle is damaged up to the front wheels and the wheels were displaced to the sill under the wheel arches. The fascia was pushed into the passenger compartment. The left and the right A-pillar were damaged and the header rails slightly buckled. The bonnet was pushed back and the windscreen was smashed. The driver seat rails were destroyed and the seat including the dummy was projected forward against the fascia. The ASI is calculated to 3.3 and THIV is calculated to 74 km/h.

The protection of vehicle occupants in impacts with the crash cushion Alpina F1-50 cannot be recommended either. The ASI with 3.3 is far above the limit of 1.4 and the THIV with 74 km/h is far above the limit of 44 km/h for frontal impact configurations with crash cushions defined in EN 1317-3.

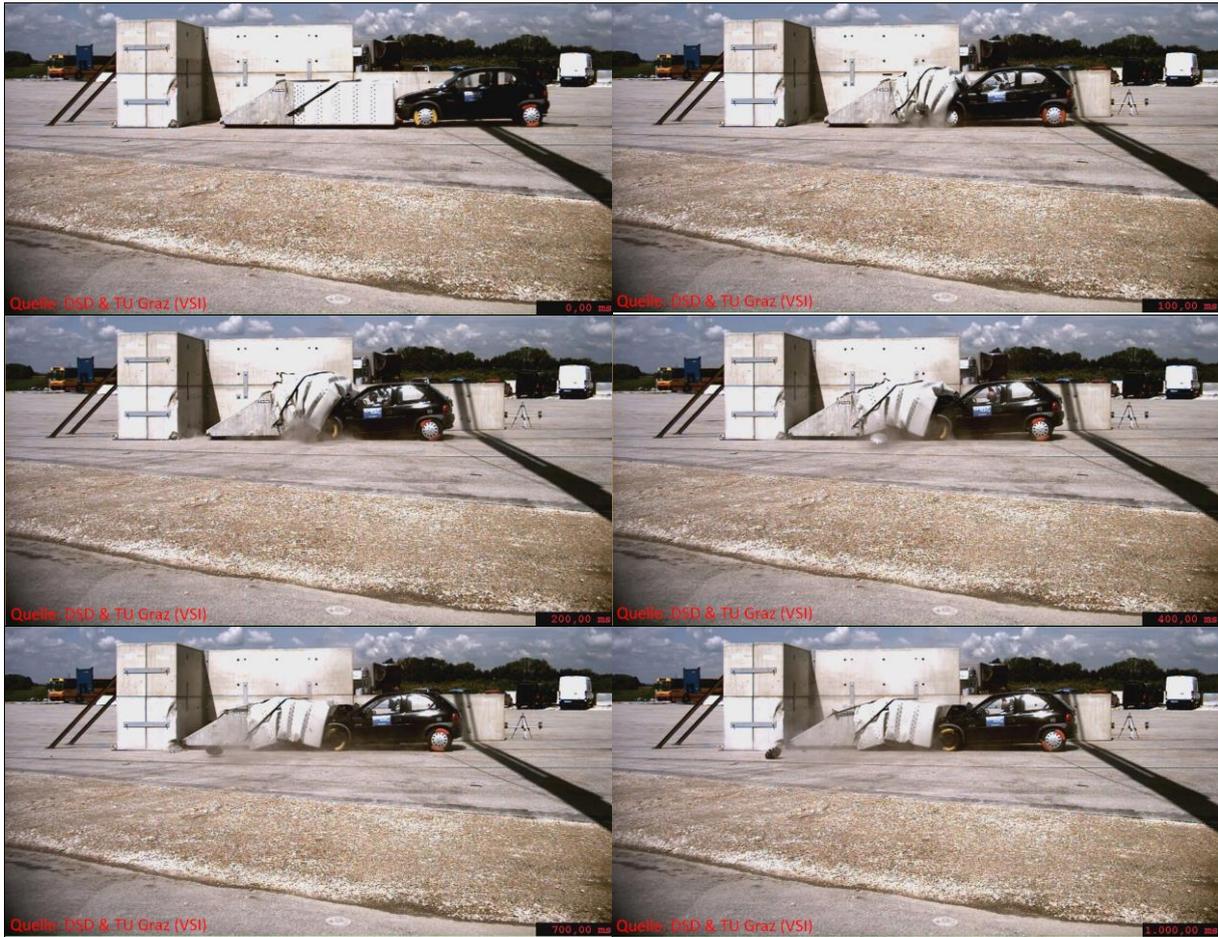
Appendix D – Crash cushion Alpina <prototype>

Compared to the Alpina F1-50 the test the vehicle is fully decelerated. After the vehicle came to a stop the crash cushion was thrust against the tunnel lay-by. From this point in time the vehicle moved backwards and the final position reached was at 0.6 m in front of the crash cushion. No lift of the rear wheels was observed.

The crash cushion was completely destroyed and the front of the vehicle was damaged. There was no contact of the wheels with the sill observed. No intrusions into the passenger compartment were observed. The ASI is calculated at 1.8 and THIV is calculated at 57 km/h.

Although the Alpina <prototype> showed better results compared to the Alpina F1-50 the injury criteria of EN 1317-3 are not met. The ASI (1.8) and THIV (57 km/h) is much better compared to the Alpina F1-50 but still above the limit of 1.4 and 44 km/h respectively. All other artefacts found in the tests of the Alpina F1-50 such as the gap between the crash cushion and the front end of the lay-by, the offset impact of the vehicle, the lack of information on performance in the event of a vehicle impacting the side of the crash cushion are also applicable for the Alpina <prototype>.
